**Traffic Safety Committee
City of Jurupa Valley City Hall
Council Chambers
September 23, 2021
3:00 P.M.
8930 Limonite Ave., Jurupa Valley, CA 92509**

STAFF REPORT

REQUESTED ALL-WAY STOP SIGN CONTROL AT THE INTERSECTION OF BAKER STREET AND 64TH STREET

**REQUESTED ALL-WAY STOP SIGN CONTROL AT THE INTERSECTION OF
RUTILE STREET AND 55TH STREET**

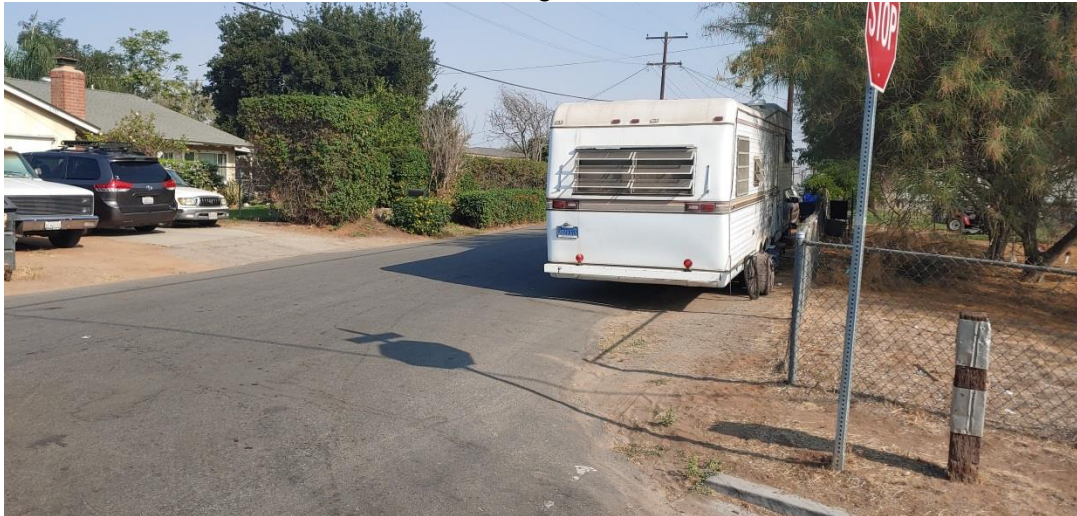
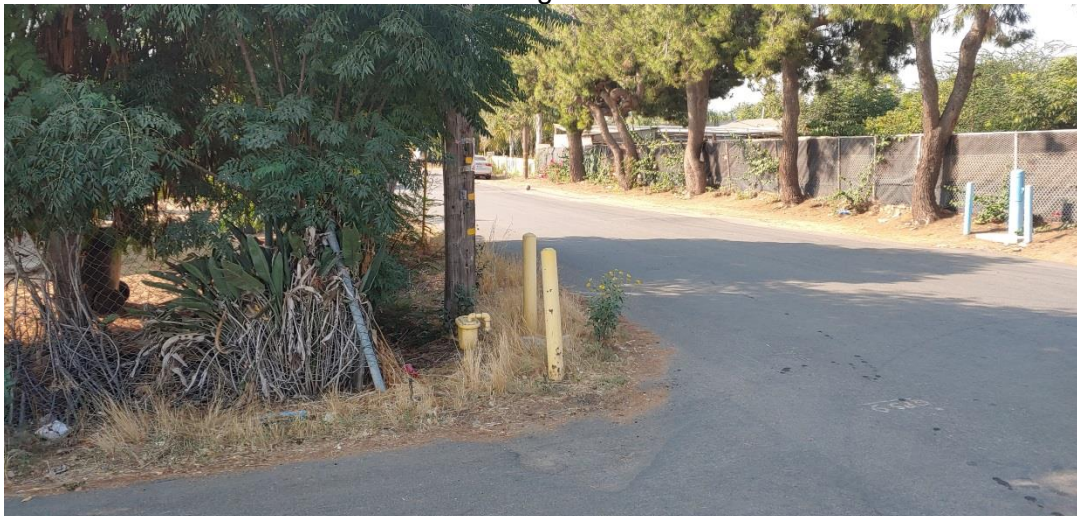
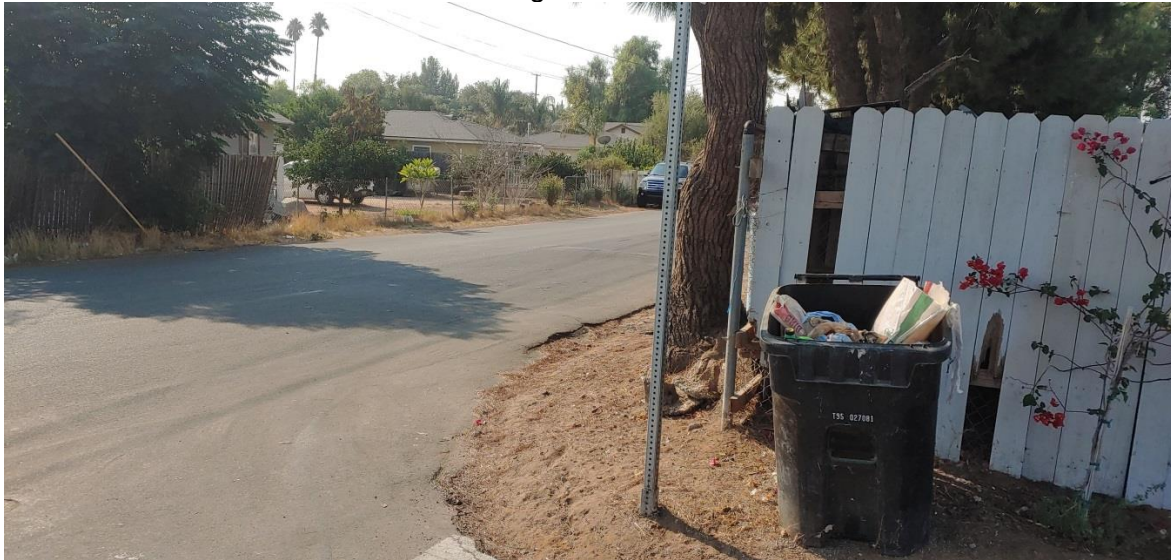
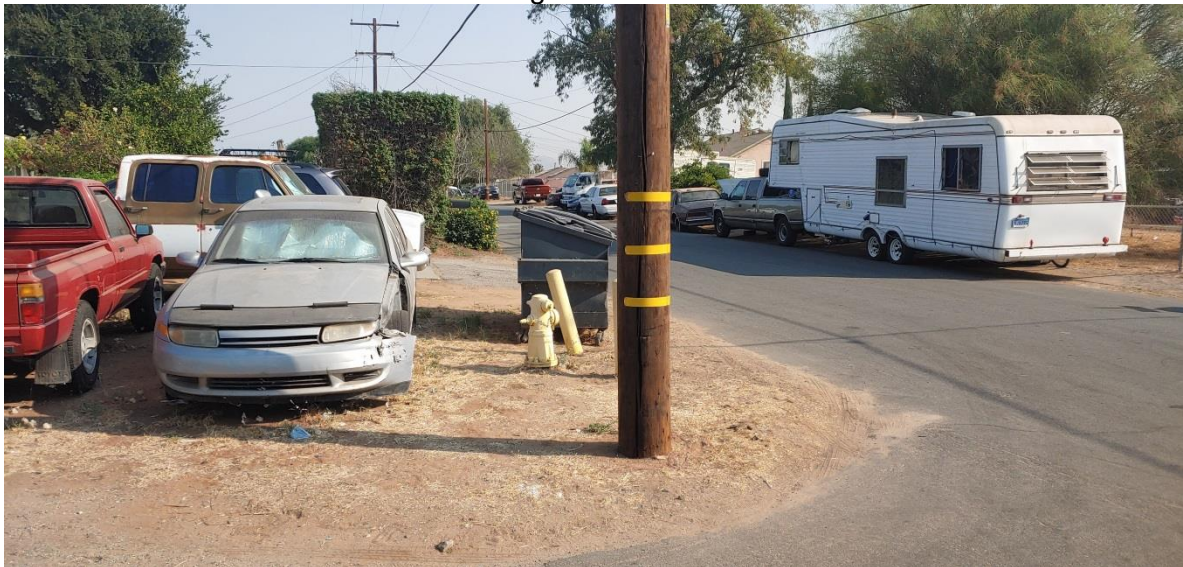
The properties at the intersection do not have what are referred to as corner cutoffs. This is where the right-of-way expands at a 45-degree angle at the intersection allowing for better visibility to approaching traffic. In addition, fences and vegetation behind those fences further limit sight lines for drivers. These conditions are visible in the photos in Attachment A.

As shown in the photos in Attachment A, there are several locations where the necessary sight distance for drivers on 64th Street is obstructed by parked vehicles, fences, utility poles, and vegetation. The corner with the most permanently-restricted line of sight is along southwest corner of the intersection where there is an approximately 6-foot-tall fence that obstructs driver's views to the south. Based on a 25 mile per hour speed limit the required sight distance is 150 feet. If vehicles on Baker Street are traveling 30 miles per hour, that distance increased to 200 feet and if they are travelling 35 miles per hour the required distance increases to 250 feet. Under current conditions the available sight distance is less than the required distance if vehicles are parked close to the intersection and with the fence obstruction.

View From Westbound 64th Street Looking North

View From Westbound 64th Street Looking South

View From Eastbound 64th Street Looking South

View From Eastbound 64th Street Looking North

1. Add stop signs along with advance warning signs and markings to Baker Street at 64th Street to place the intersection under all-way stop sign control,
2. Include pole-top flashers to all stop signs at the intersection, and
3. Consider the placement of corner curbing to define the intersection limits

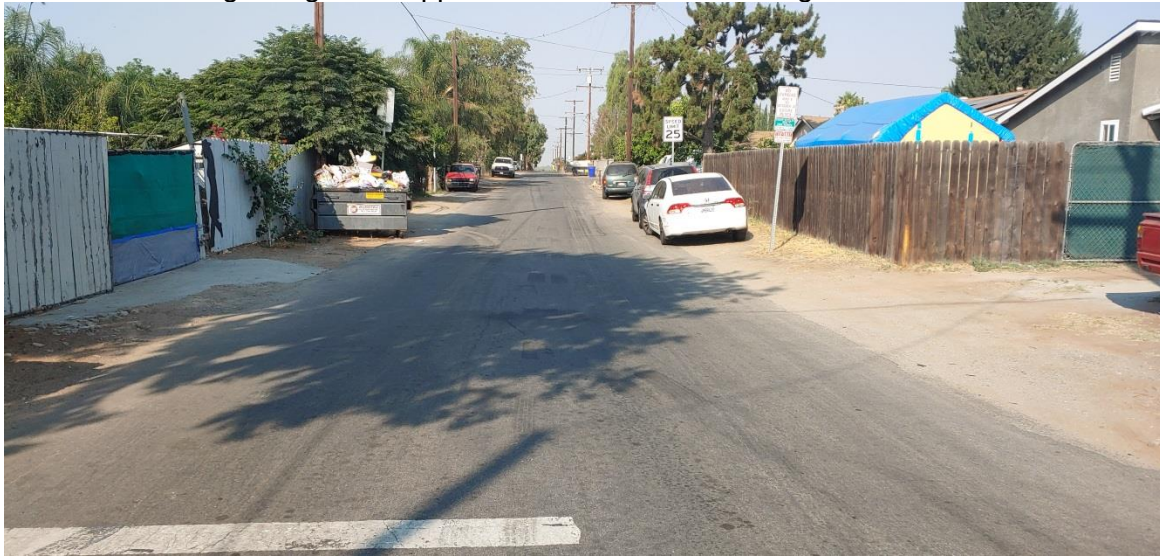
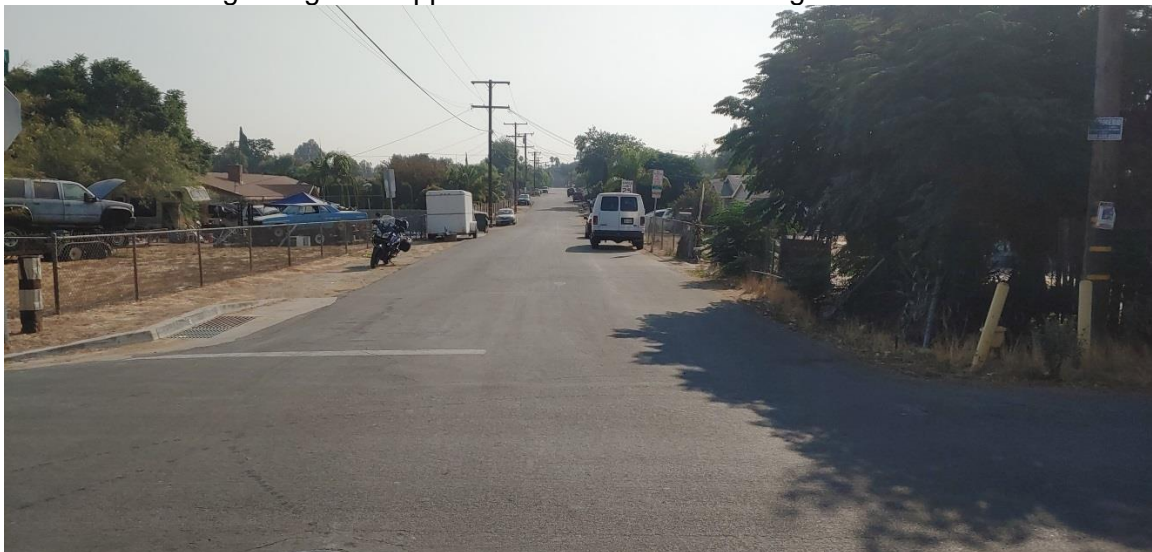
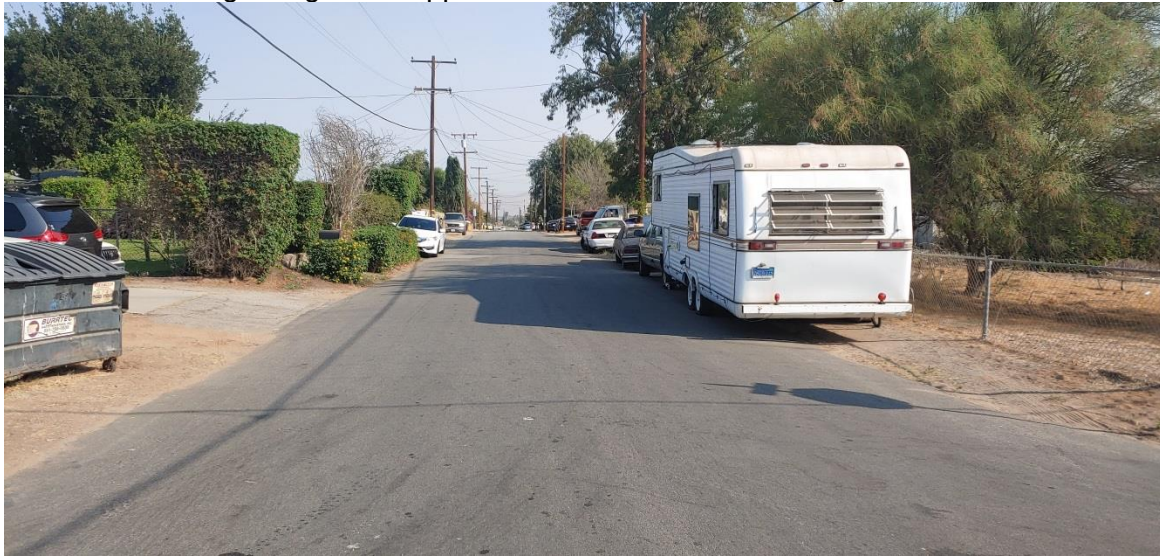
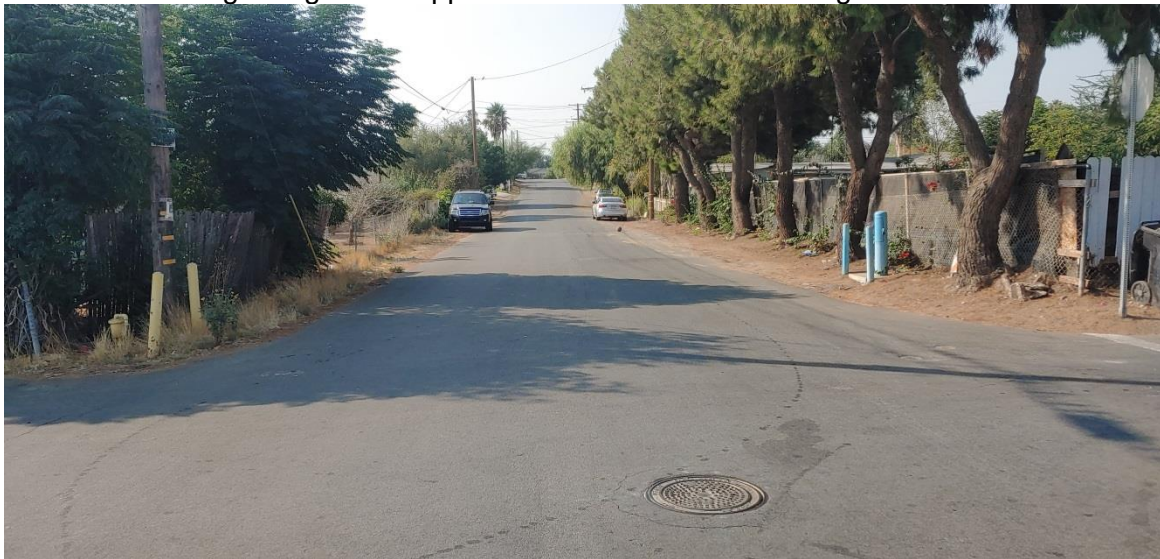
Staff reviewed the field conditions at the intersection and noted that there were multiple vehicles parked close to the intersection along Baker Street, however vehicles parked along 64th Street were typically parked farther from the intersection. This may be related to the fact that all of the corner properties front to Baker Street and not 64th Street. So, vehicles parking in front of those properties would be parked on Baker Street. In addition, there were several illegally parked vehicles and what appeared to be inoperable vehicles.

The parking proximate to the intersection restricts the ability of drivers on 64th Street to see oncoming traffic without moving well out into the intersection and for drivers on Baker Street to see vehicles trying to cross or turn onto Baker Street. Portions of Baker Street in this area have a wide dirt shoulder allowing some vehicles parked along the street to be outside of the travel lanes and allow vehicles on Baker Street to travel faster than the posted speed limit and not be close to parked vehicles. Other areas the street is very narrow creating the need for slower

On-Street Parking Along West Approach of 64th Street Looking West

On-Street Parking Along East Approach of 64th Street Looking East

On-Street Parking Along North Approach of Baker Street Looking North

On-Street Parking Along South Approach of Baker Street Looking South

2. Install all-way stop sign control with flashing beacons to emphasize the sign presence along with associated pavement markings.
3. Install no parking signs near the intersection to maintain suitable corner sight distances with a long-term strategy to add curbing that can be used to mark the intersection boundaries and restrict parking in that area.
4. Provide staff with alternative direction.

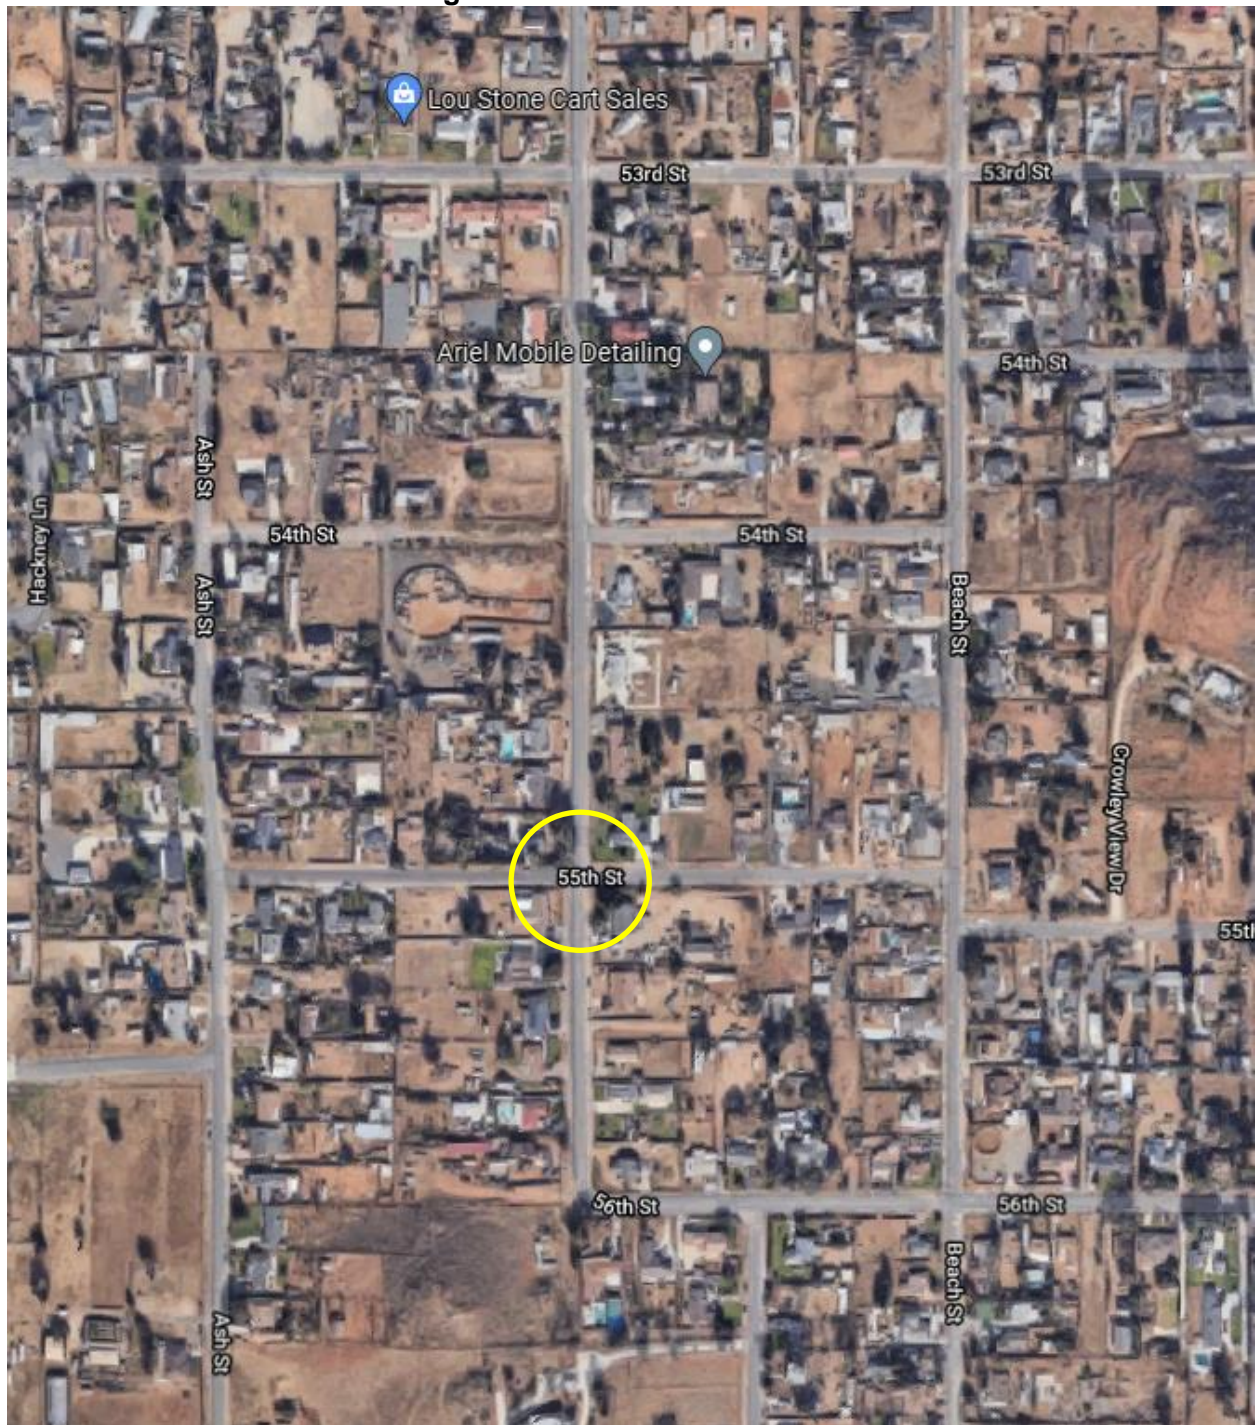
Figure 1: Intersection Location

Rutile Street is a two-lane local street with a posted speed limit of 40 miles per hour and a current Engineering & Traffic Survey (E&TS) for that posted speed. The intersection with 55th Street is approximately 600 feet north of the 90-degree knuckle intersection with 56th Street and about one-quarter mile south of the all-way stop controlled intersection with 53rd Street. There are warning signs at Rutile Street and 56th Street recommending a travel speed through the corner of 15 miles per hour. There are dirt shoulders along both Rutile Street and 55th Street. To the east 55th Street extends only one block where it is then offset to the south. To the west 55th Street extends just one block where it terminates at Ash Street. All of the 55th Street approaches at Beach Street, Rutile Street, and Ash Street are stop controlled. The intersection location and vicinity are shown in **Figure 1**.

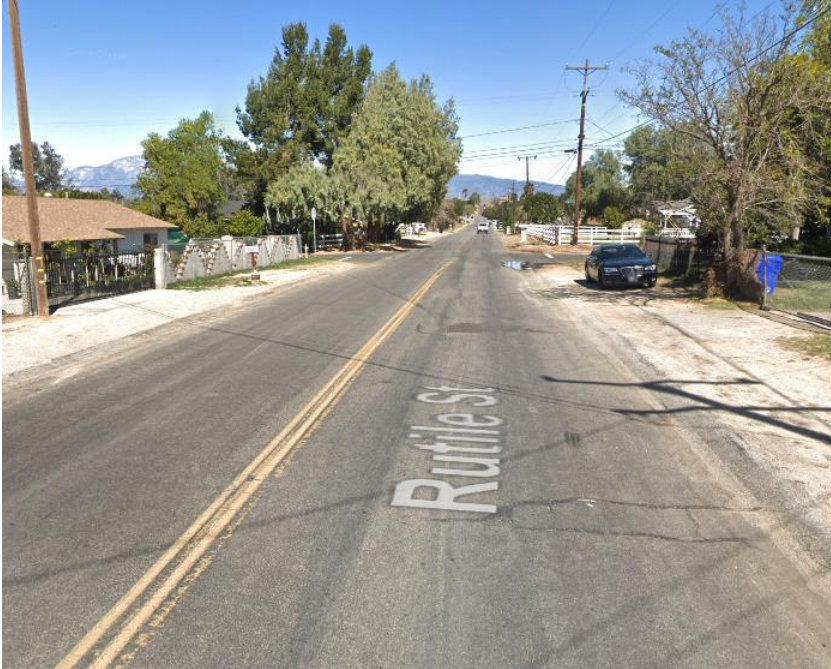
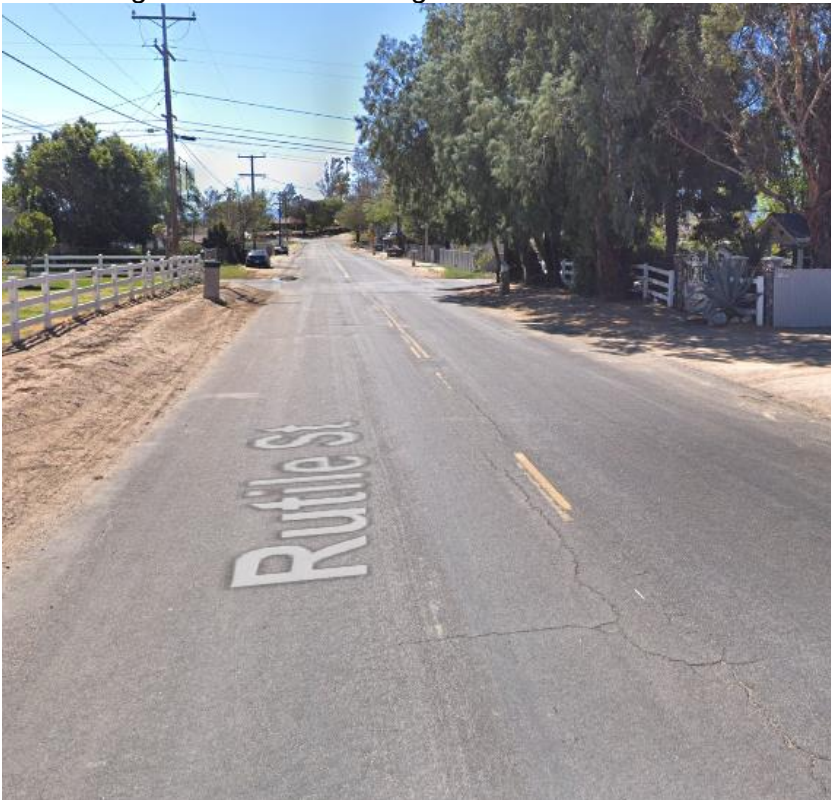
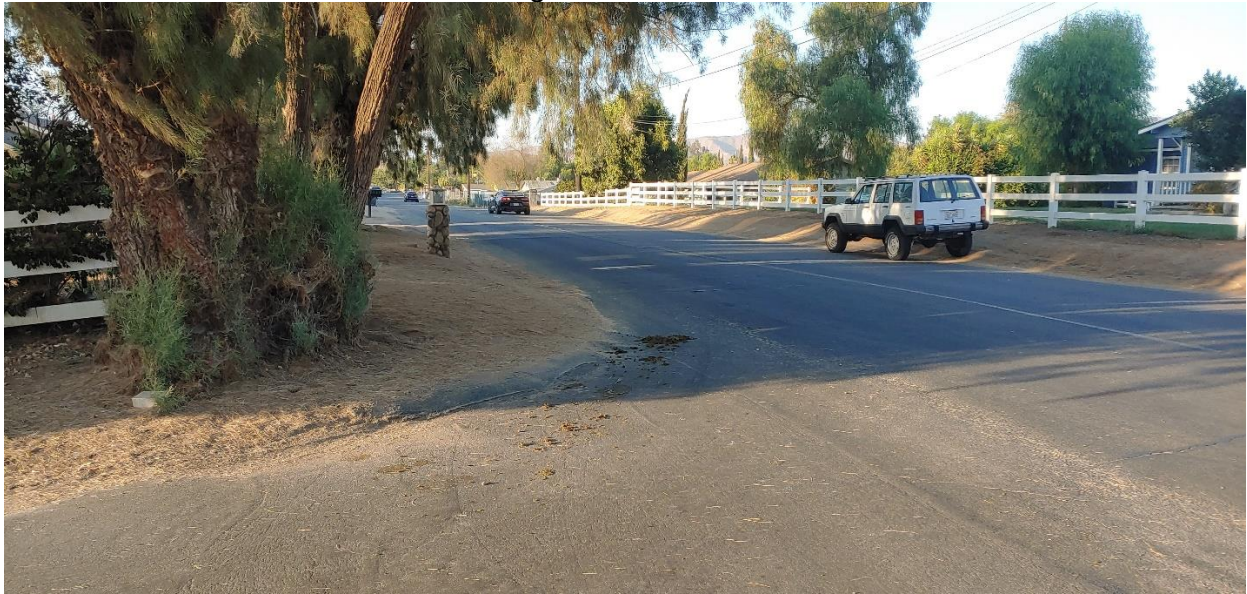
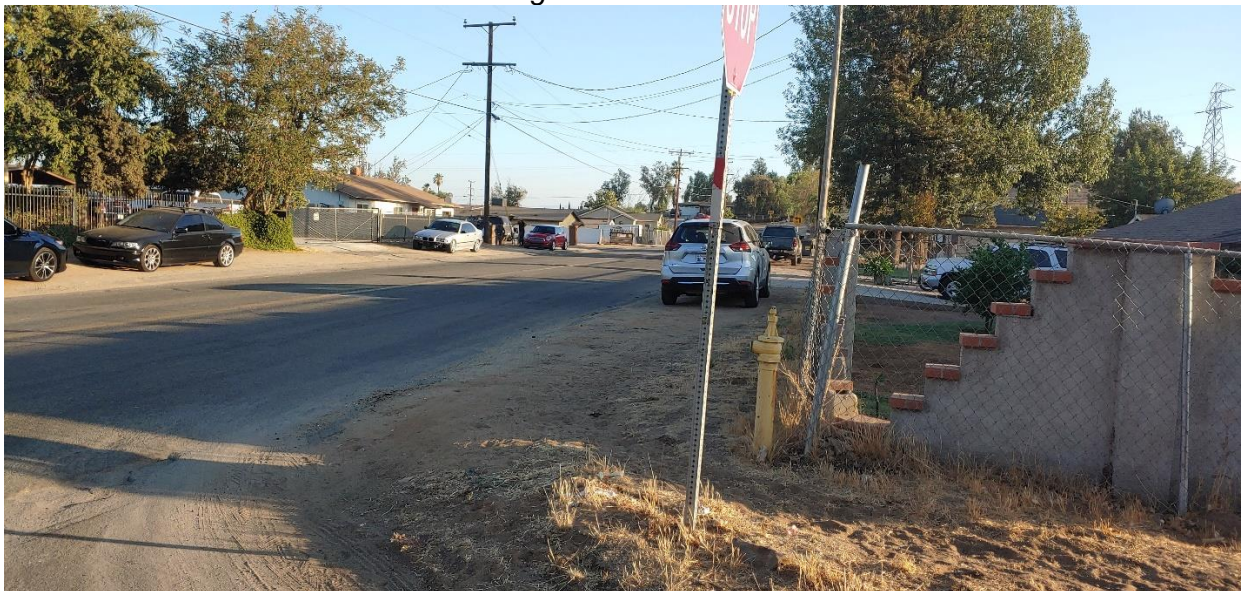
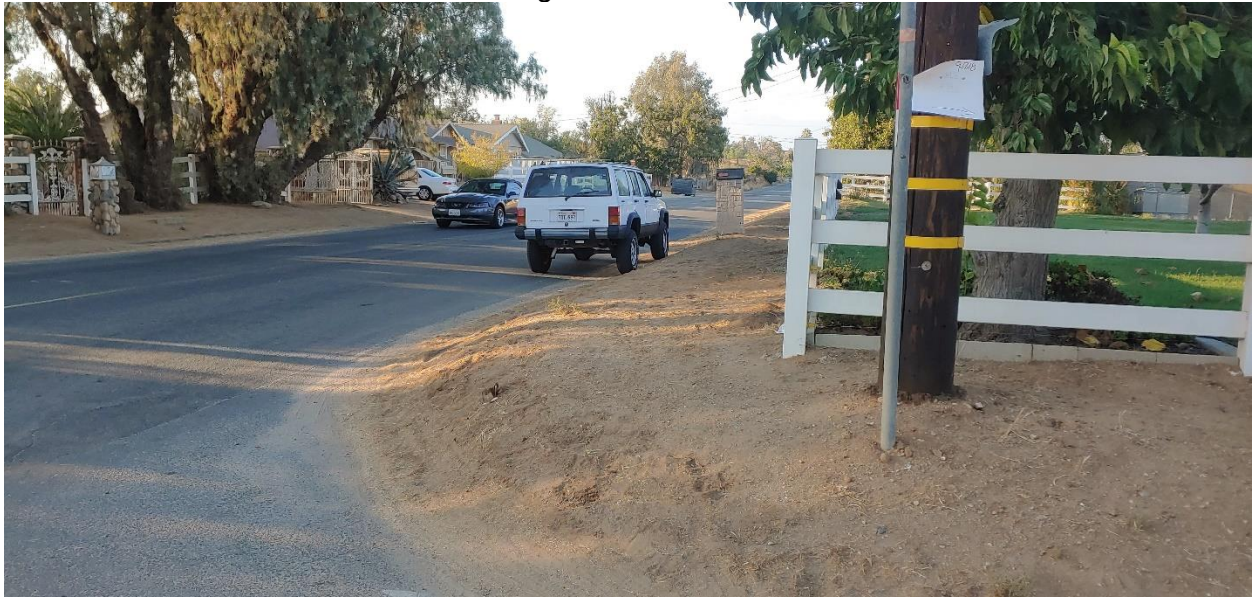
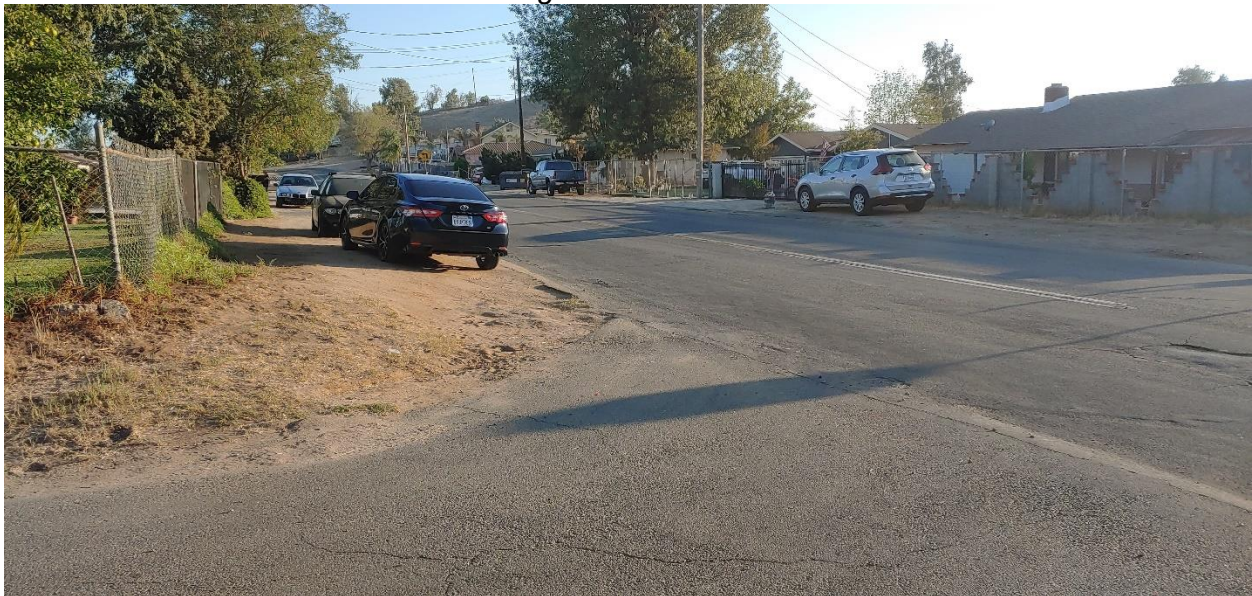
View Along Rutile Street Looking North

View Along Rutile Street Looking South

View From Eastbound 55th Street Looking North

View From Eastbound 55th Street Looking South

View From Westbound 55th Street Looking North

View From Westbound 55th Street Looking South

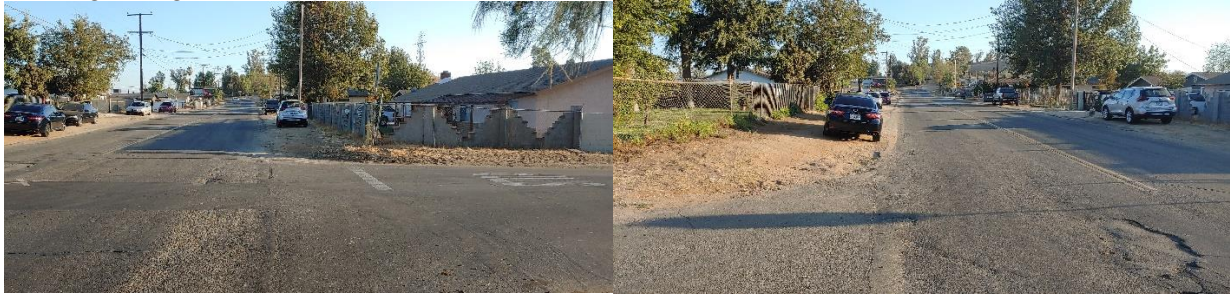
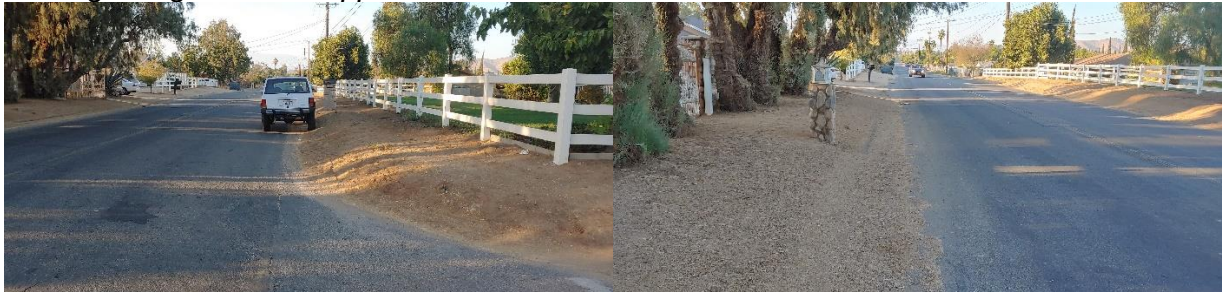
Staff reviewed the field conditions at the intersection on several occasions. Rutile Street in this area has 2 lanes and wide dirt shoulders. On the north side of the intersection, the westside shoulder is relatively flat, while the eastside shoulder has a sharp slope rising right behind the asphalt berm pavement edge. That slope limits any parking along that quadrant of the intersection. South of the intersection there was a limited amount of on-street parking observed. Photos of the intersection vicinity are provided in **Attachment A**.

Parking Along South Approach of Rutile Street

Parking Along the North Approach of Rutile Street

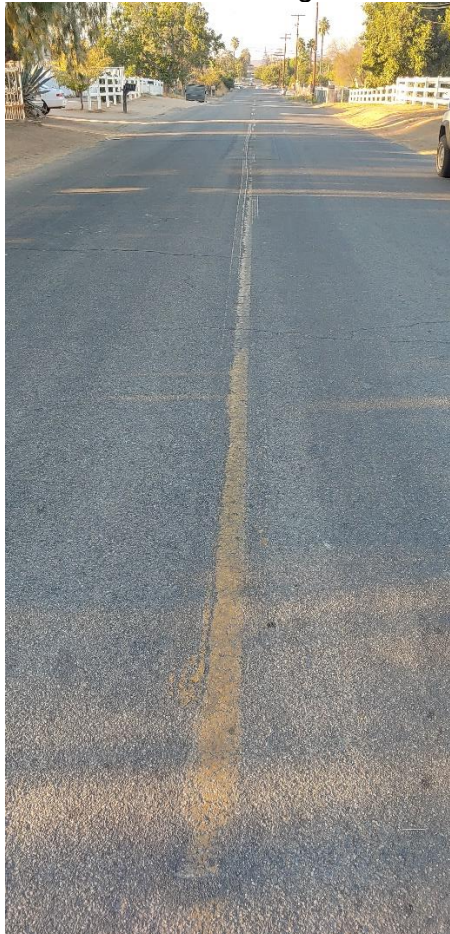
It was observed during the field visits that the existing centerline striping is very worn and faded as shown in the final photo in Attachment A. Refreshing that centerline near the intersection could help provide reinforcement to drivers of the presence of the intersection and the potential for turning or crossing vehicles. No intersection advance warning signs are present along Rutile Street. However, given the available sight distance and posted speed of the street a warning sign would not be required.

Faded Centerline String on Rutile Street

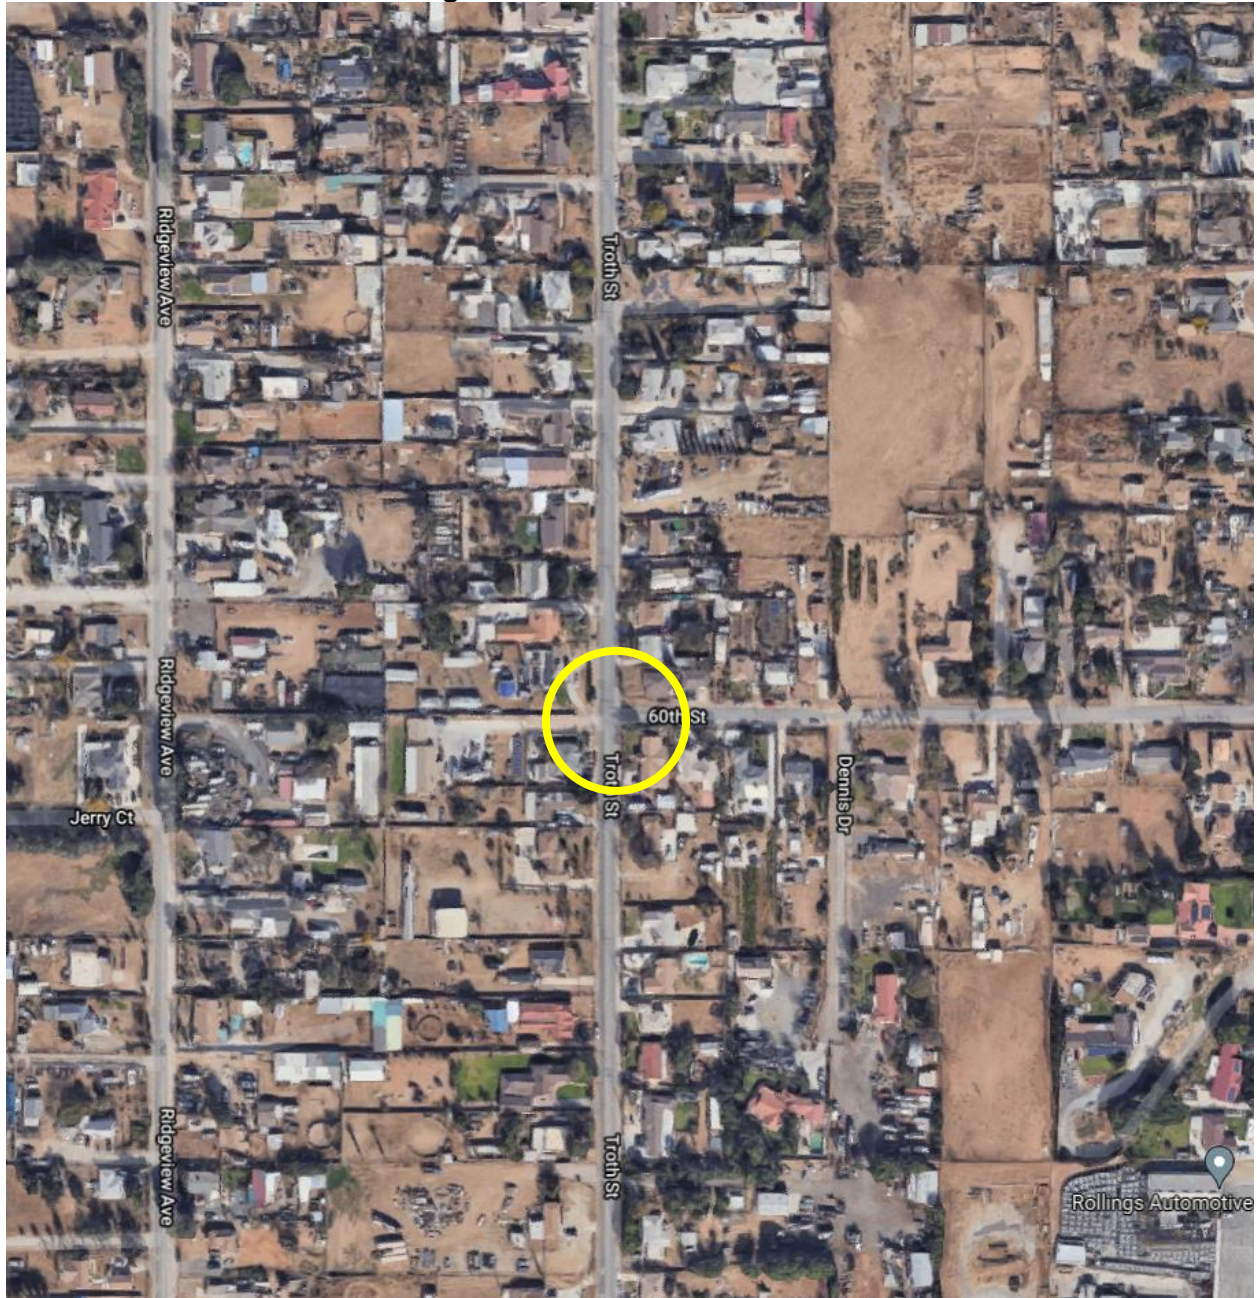
Figure 1: Intersection Location

posted speed limit is 25 miles per hour. The street has dirt shoulders of varying widths and numerous driveways along the street. Figure 1 shows the intersection location and the general vicinity.

60th Street extends easterly from Troth Street and terminates at Beach Boulevard West of Troth Street the corridor is a private driveway serving several residences.

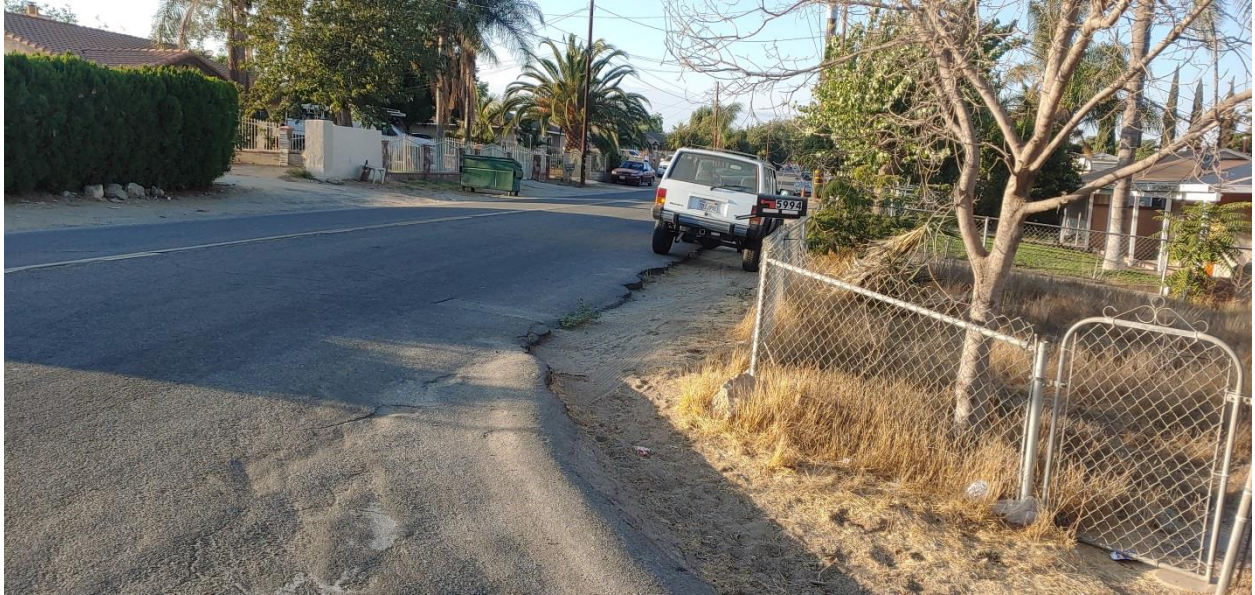
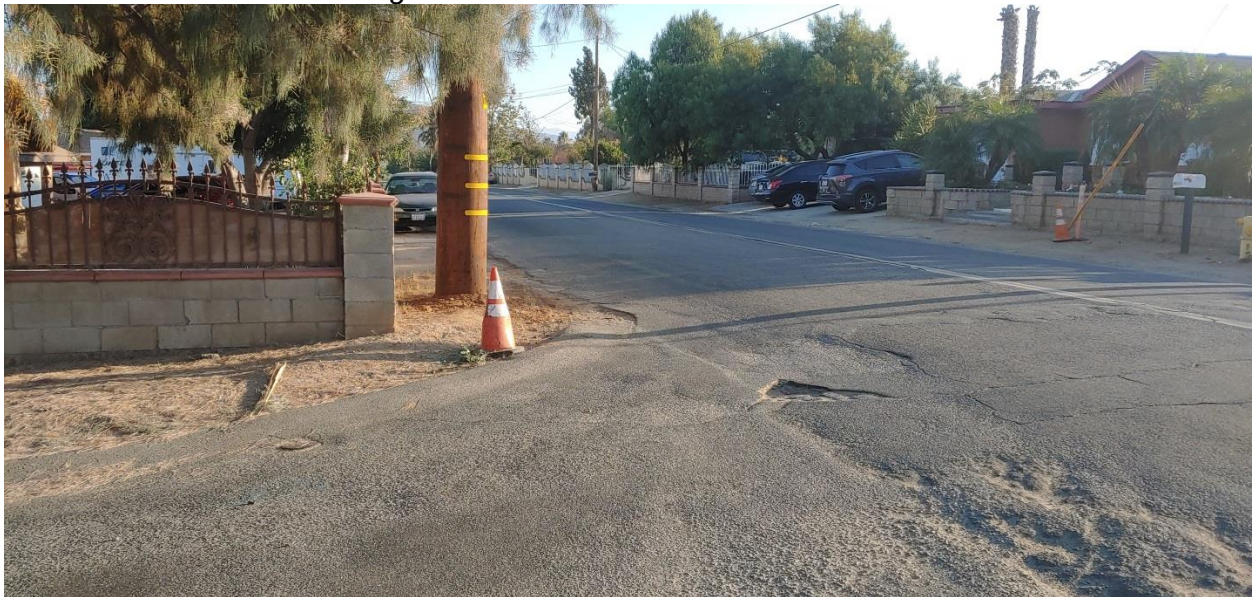
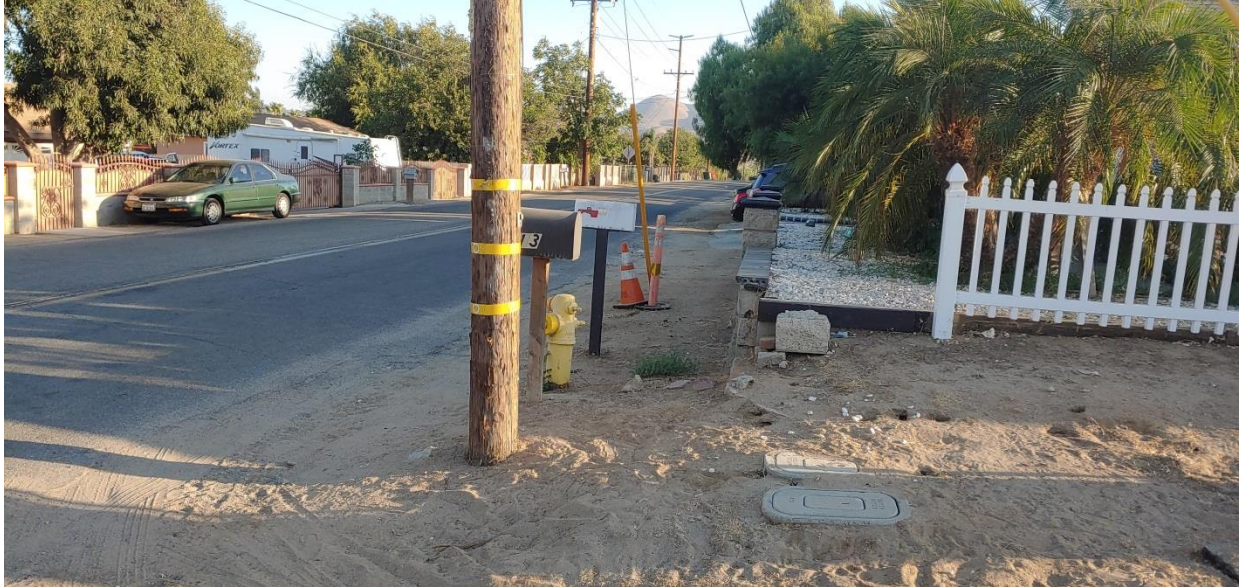
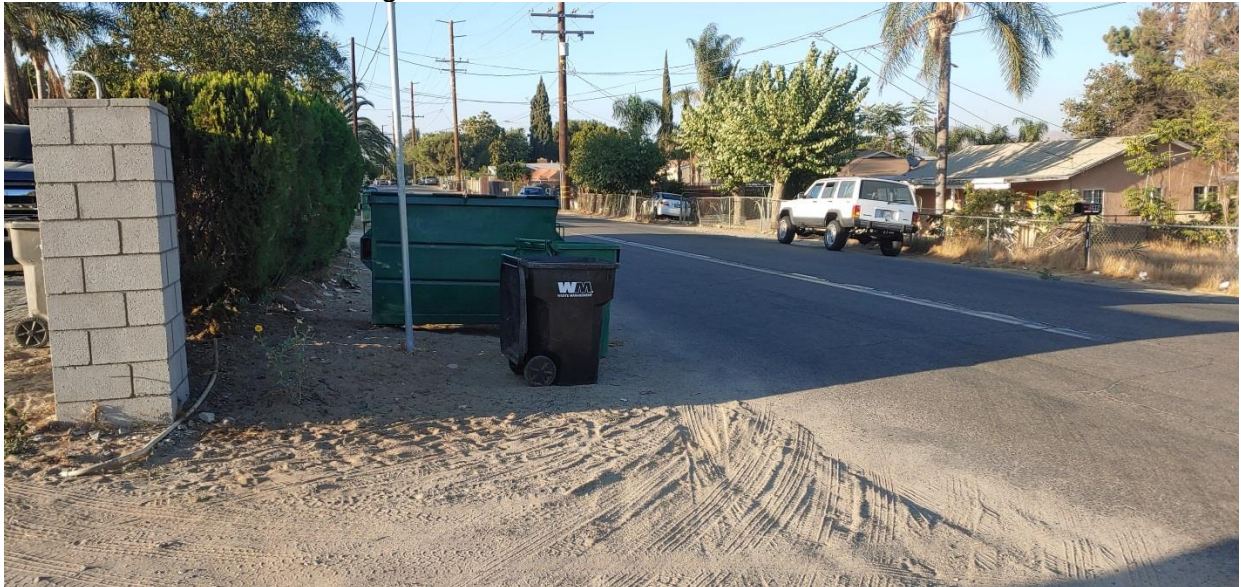
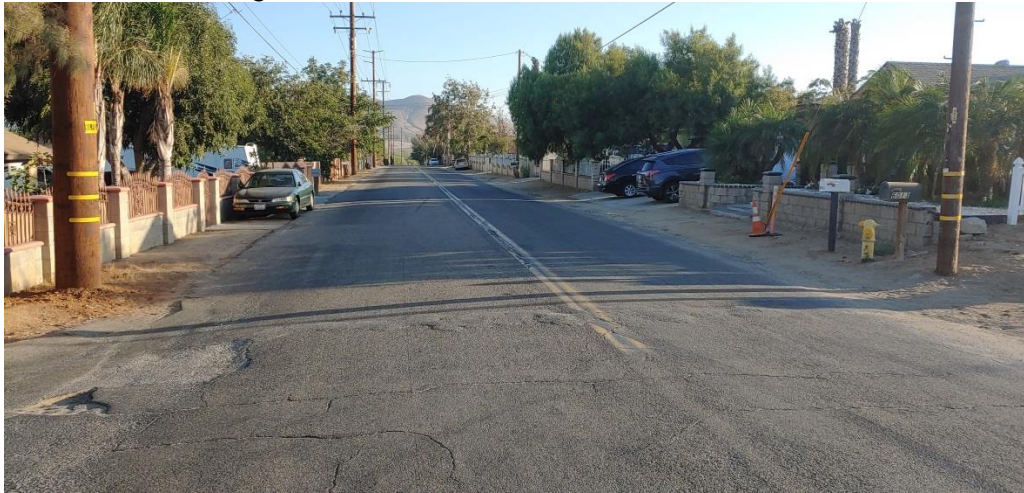
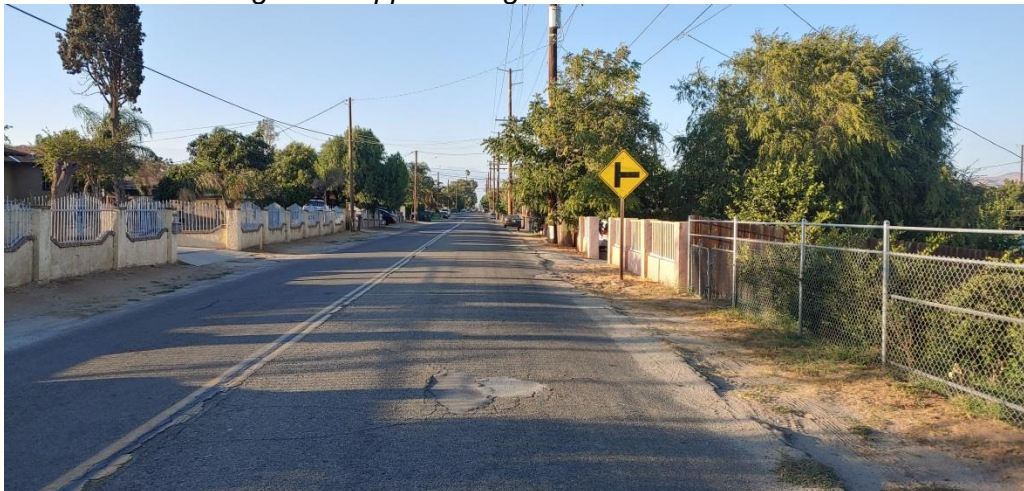
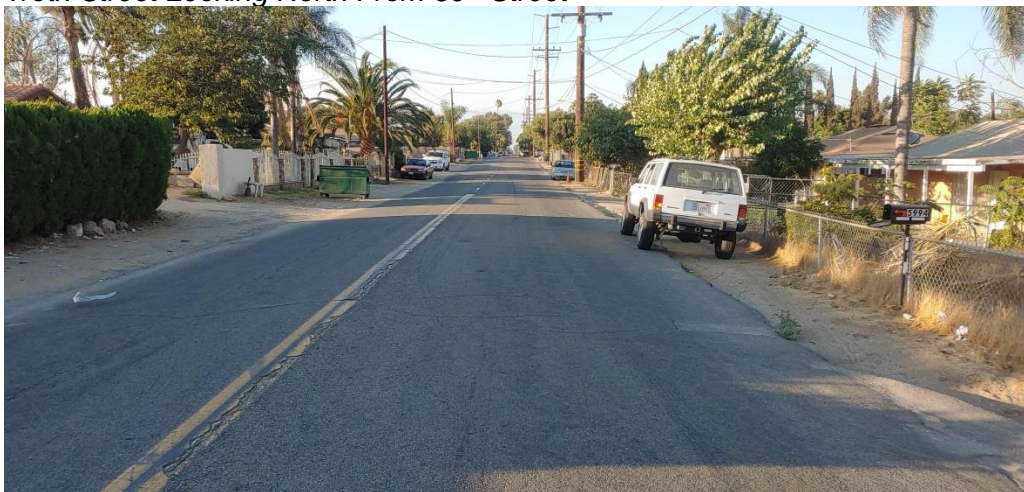
Code (CVC) rule for prima facia speeds in local residential areas. The travel lanes are approximately 12 feet wide and the shoulders vary in width. It was observed that along multiple sections of the Troth Street there are substantial shoulder drop-offs that need to be addressed by re-grading the shoulders of the street. The street pavement along both streets is in relative poor condition with multiple pothole patches and broken edges along the sides of the streets.

Westbound 60th Street Looking North

Westbound 60th Street Looking South

Eastbound 60th Street Looking North

Troth Street Looking South From 60th Street

Troth Street Looking North Approaching 60th Street

Troth Street Looking North From 60th Street
